Calero Trails Master Plan

Site Tour Summary

Addendum
November 2010

Santa Clara County Parks

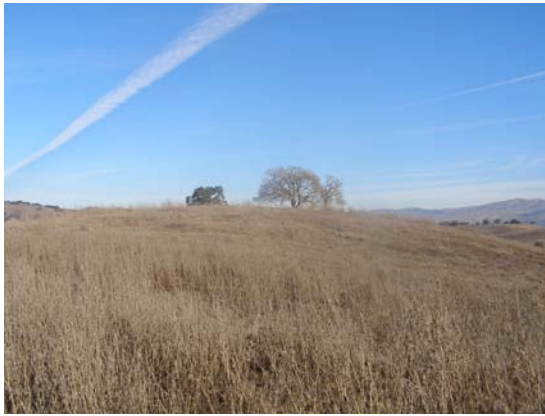
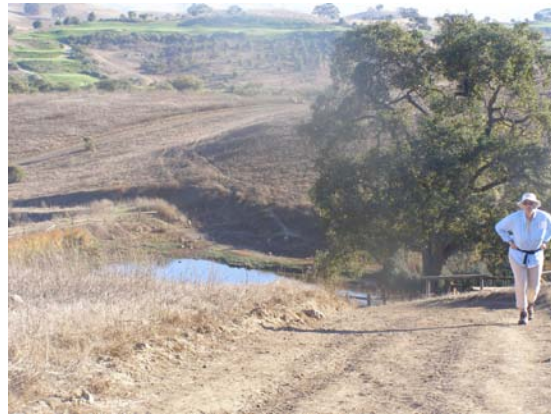
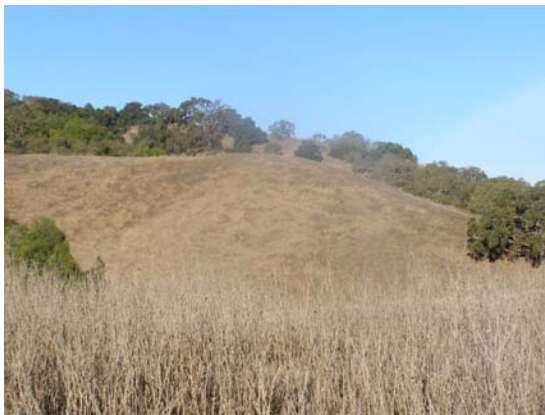
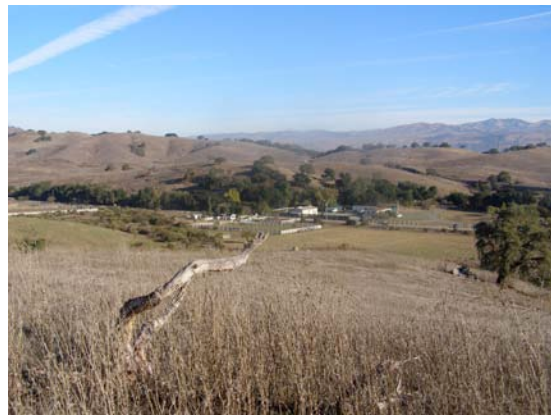
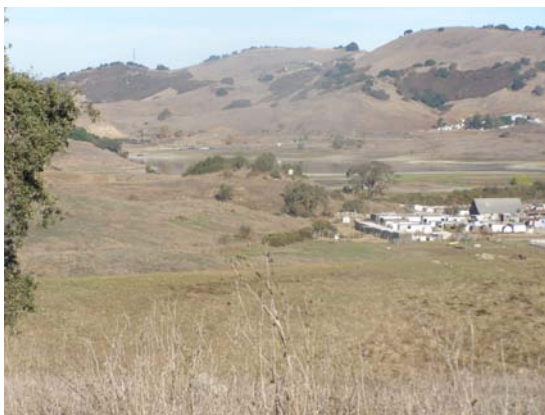
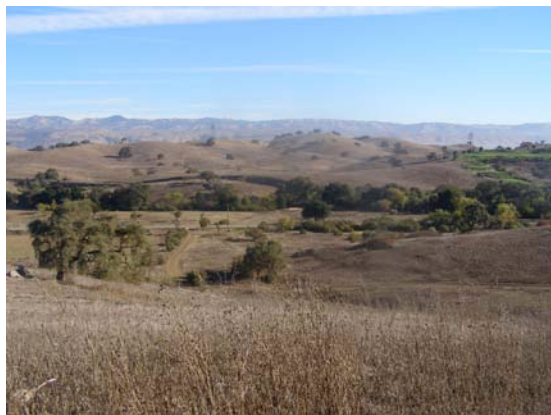
Stop 1: Pena Trail Near Picnic Area/Pond

The Pena Trail is too steep in many places and as such is difficult to maintain each year. Consider relocating trail access, and converting the Pena Trail to an “unmaintained” access road for access to the water tank. A new trail could be located on the other side of the knoll which is to the north of the Pena Trail, and could provide access to the Vallecitos and Los Cerritos Trails.

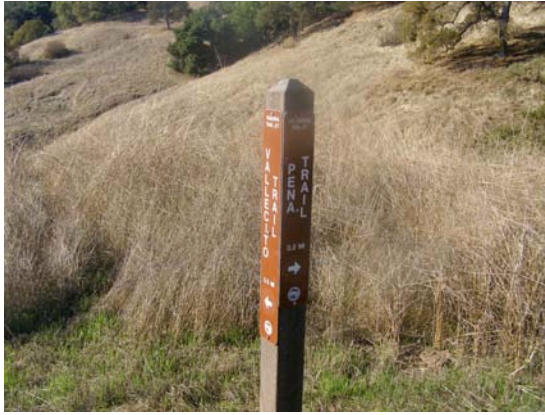
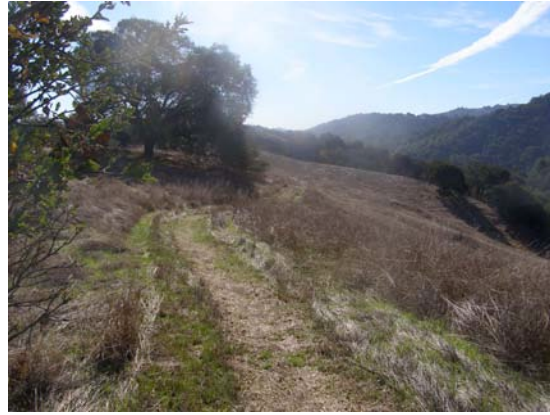
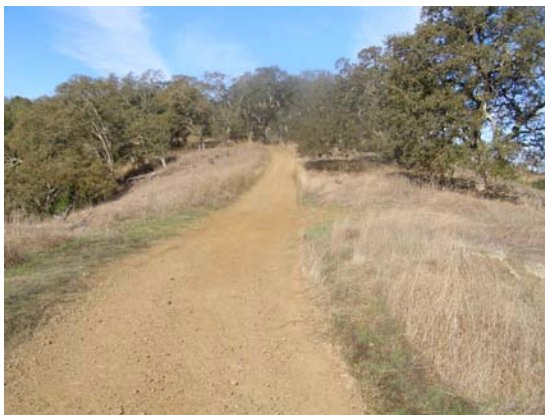
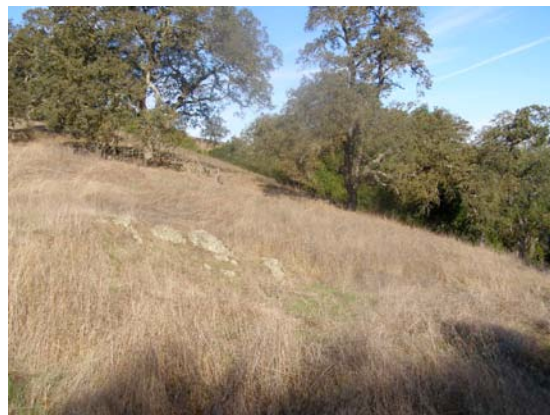
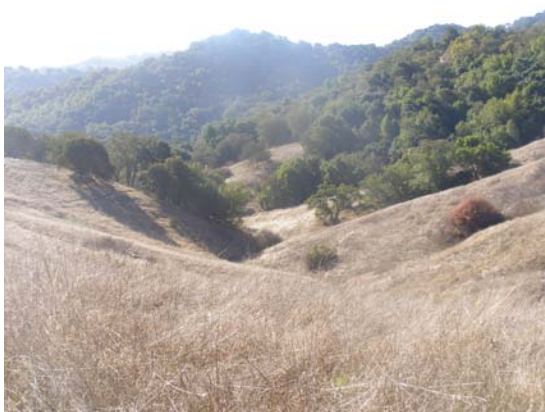
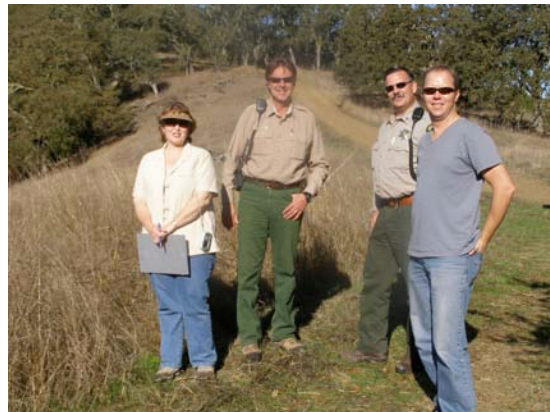
Stop 2: Pena/Vallecitos Trails Junction

If the Pena Trail is closed and a new access trail is created, provide a realigned Los Cerritos Trail connection to the Vallecitos Trail at this location. Also, consider an “upper Vallecitos” Trail alignment that stays on higher ground and may be dryer in Winter months, while the current Vallecitos Trail alignment that follows the drainage is desirable in the hot summer months.

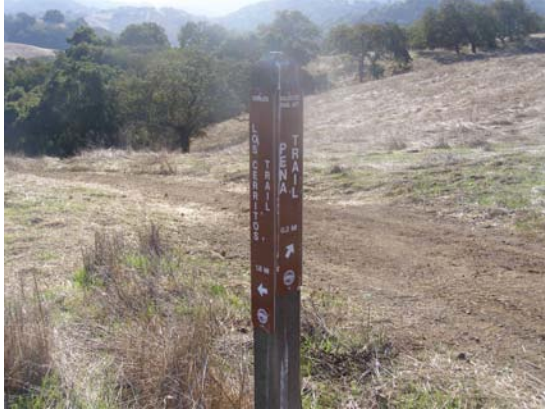
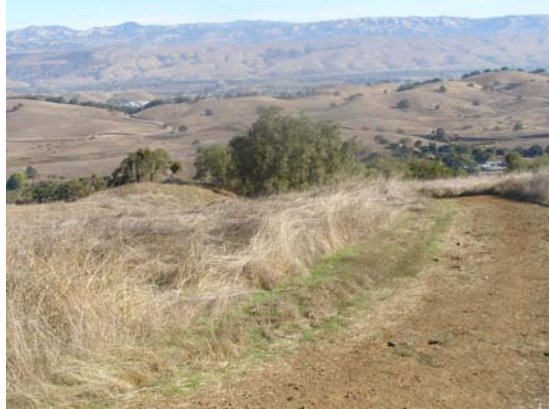
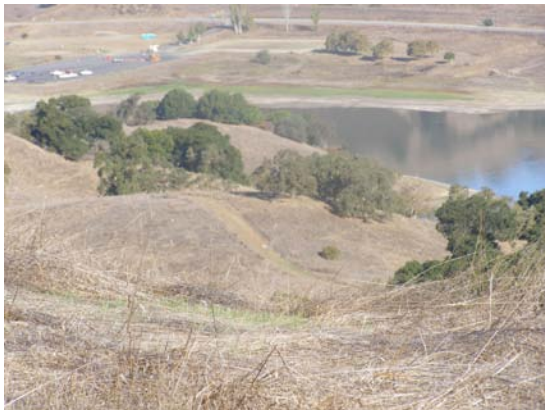
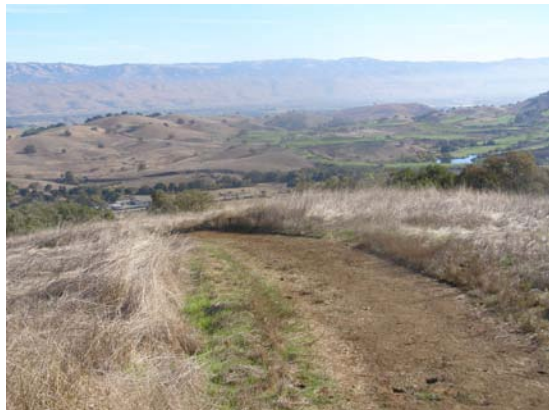
Stop 3: Pena/Los Cerritos Trails Junction

With the closure of the Pena Trail, the Los Cerritos Trail would be re-aligned to connect with the Vallecitos Trail to the southeast, and would follow the lake edge contours to the west.

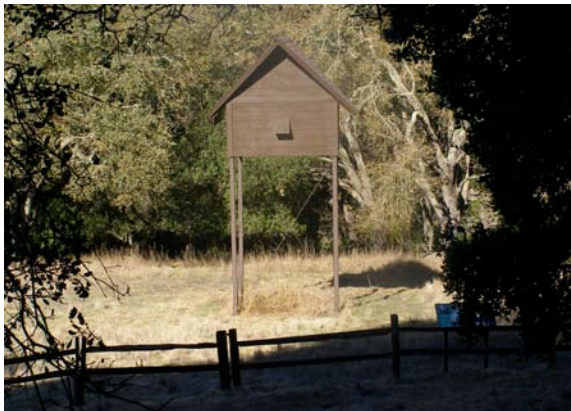
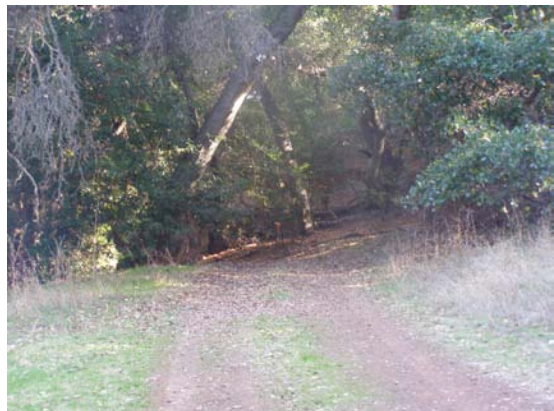
Stop 4: Calero Bat Inn

This is an important interpretive location and trail access needs to be maintained suitable for vehicles.

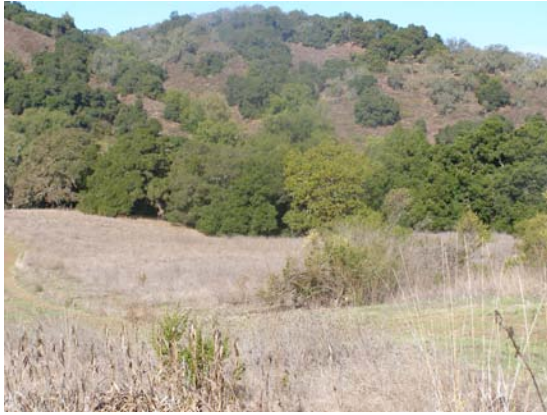
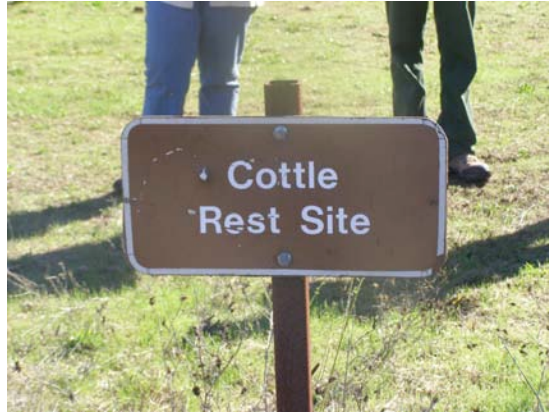
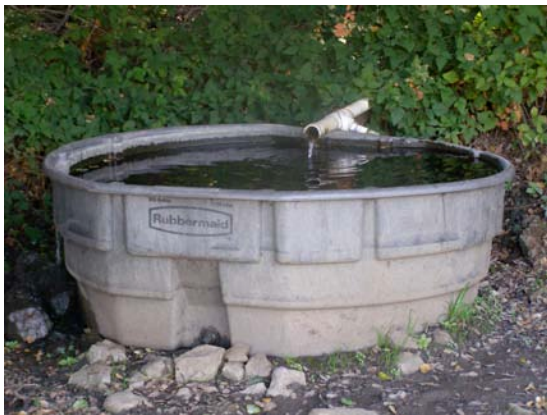
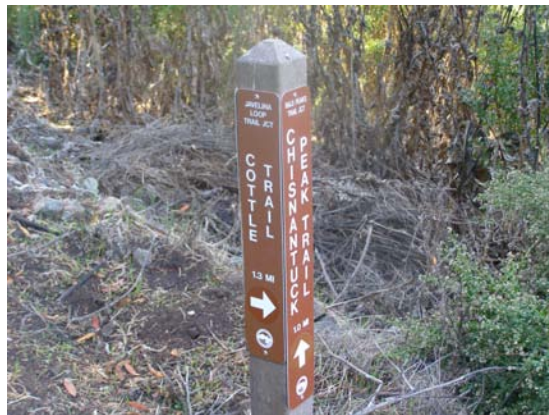
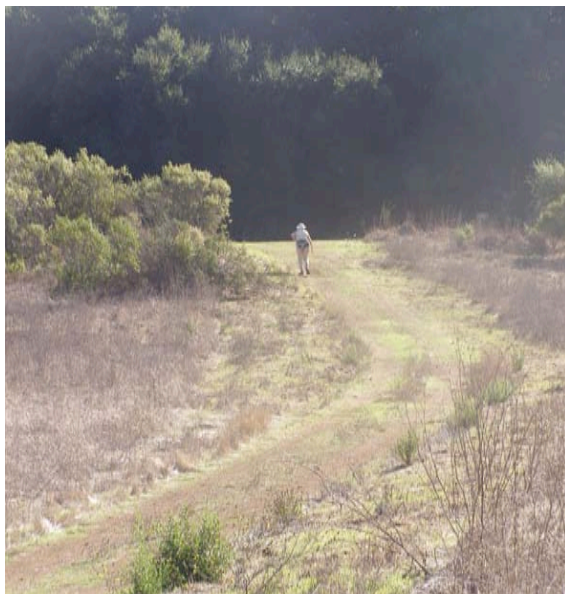
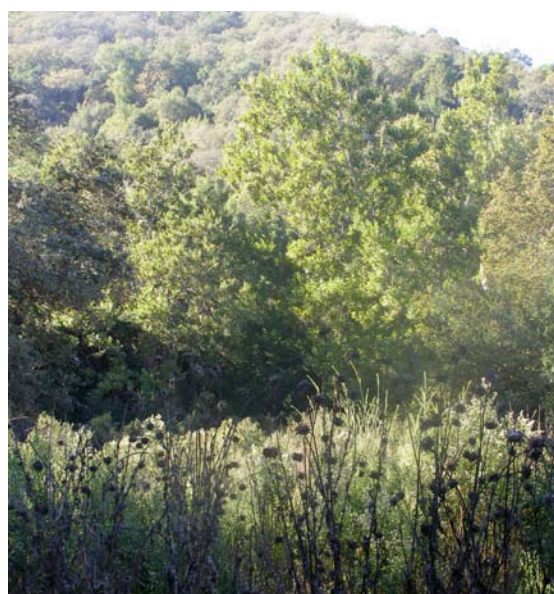
Stop 5: Cottle /Chisnantuk Peak Trails Junction

This area has potential for backcountry camping. The Chisnantuk Peak Trail is problematic for bike use and has one area that is difficult for quad turning. A trail realignment may be possible if the adjacent Open Space Preserve property could be considered for a joint trail that crosses jurisdictional boundaries.
